BEAVERDAM RUN DAM

FD-NO. PA. 805

PHASE I INSPECTION REPORT

Beaverdam Run Dam (PA 805), Ohio River
Basin, Beaverdam Run, Cambria County,
Pennsylvania. Phase I Inspection Report.

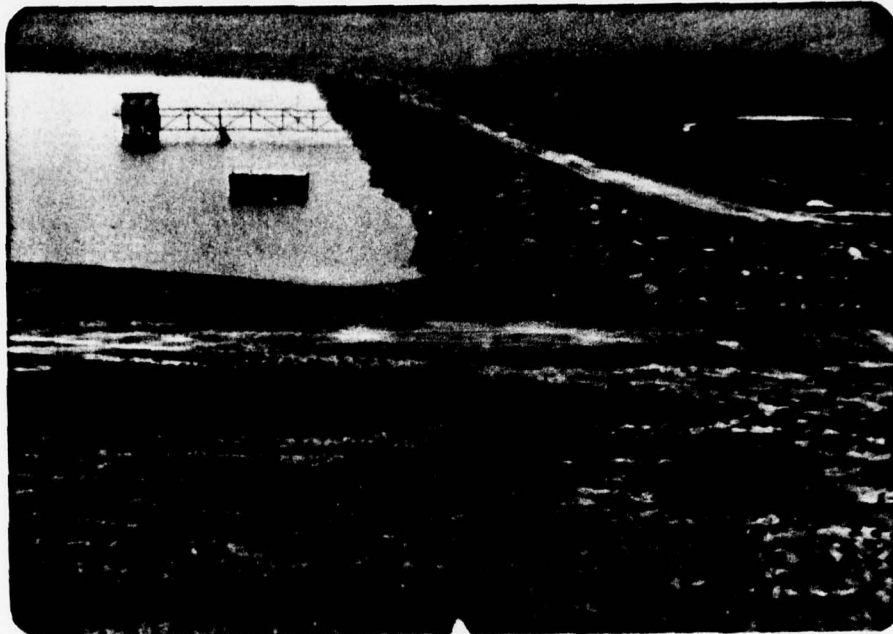
Upstream Face
